CONNECTICUT RIVER BASIN
WEST HARTFORD, CONNECTICUT

TALCOTT RESERVOIR DAM

PHASE 1 INSPECTION REPORT
NATIONAL DAM INSPECTION PROGRAM

MAY, 1981

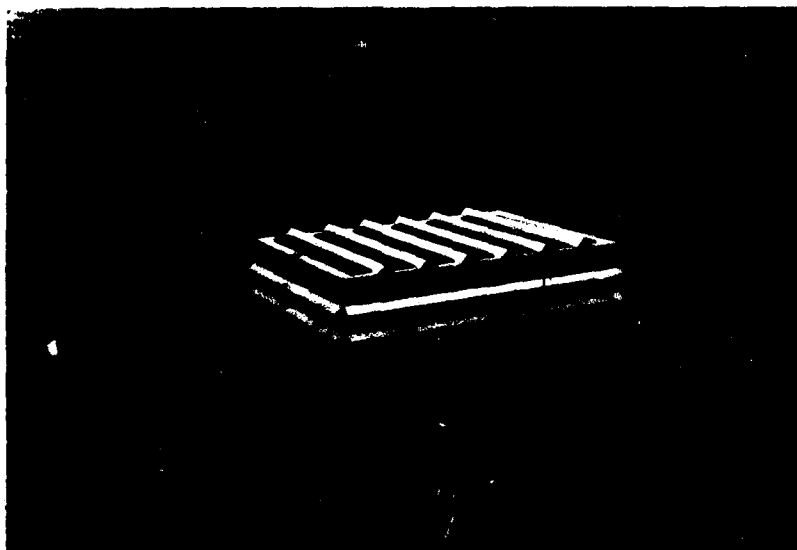
C-8 PRINCIPAL SPILLWAY INLET
